# PAVEMENT MANAGEMENT FINAL PROJECT REPORT

**CITY OF SEBASTIAN, OH**

**Tuesday, January 08, 2019**

**Pavement Management Group**

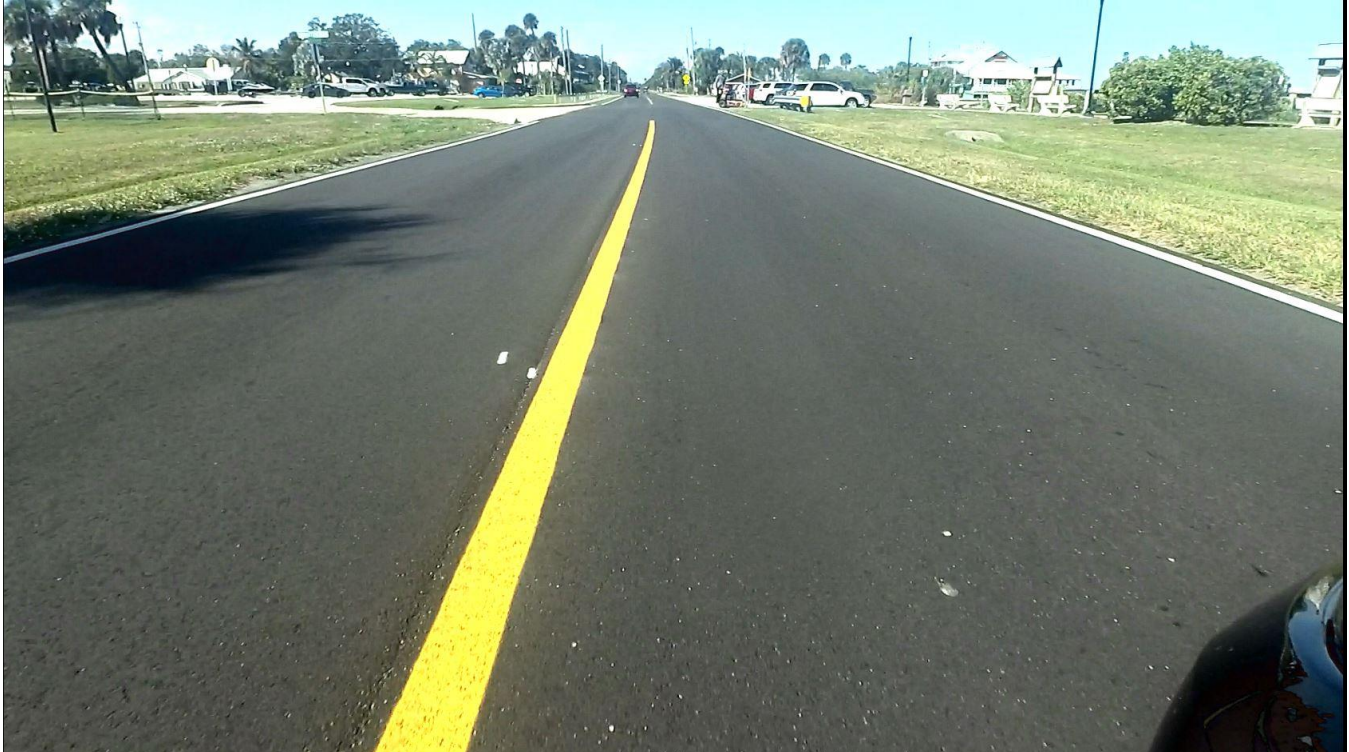
INDIAN RIVER DR | SECTION 02 | PCI 100

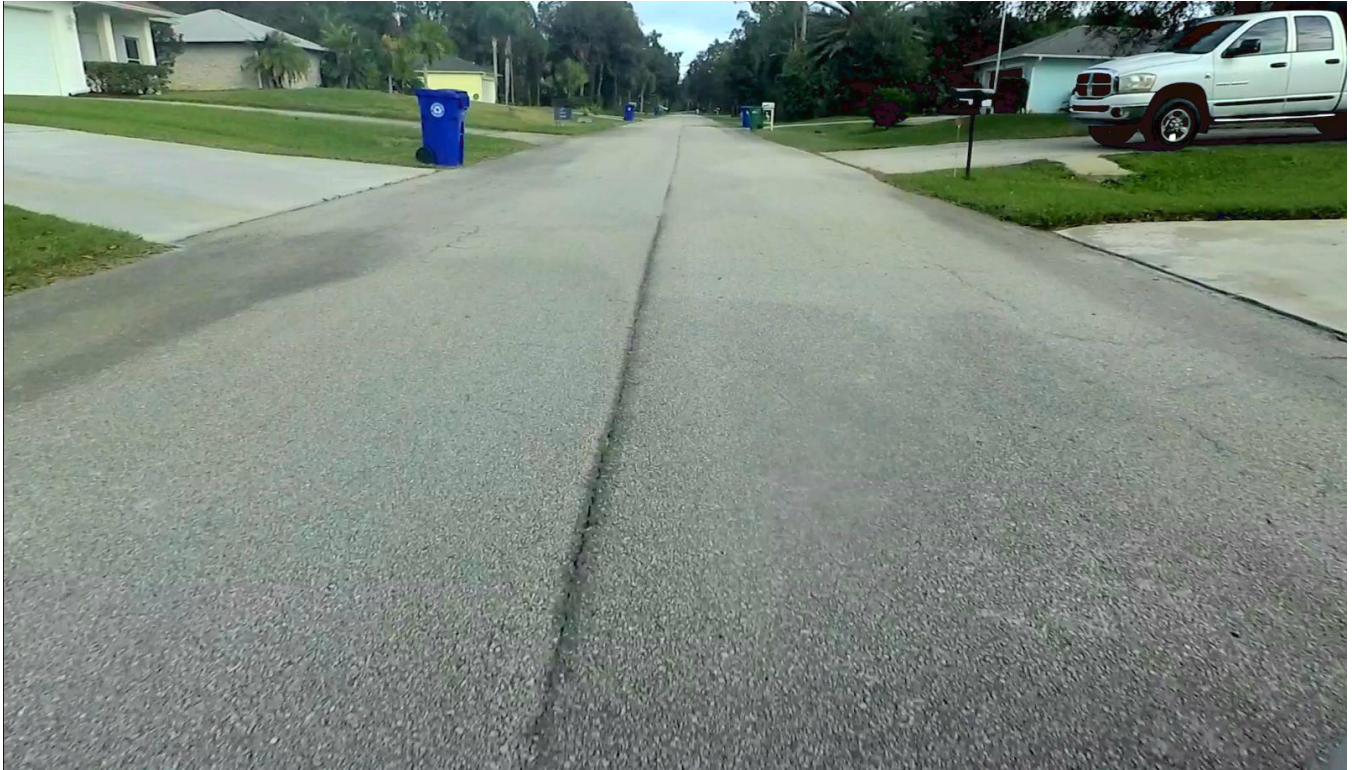
BROOKEDGE TER | SECTION 02 | PCI 89

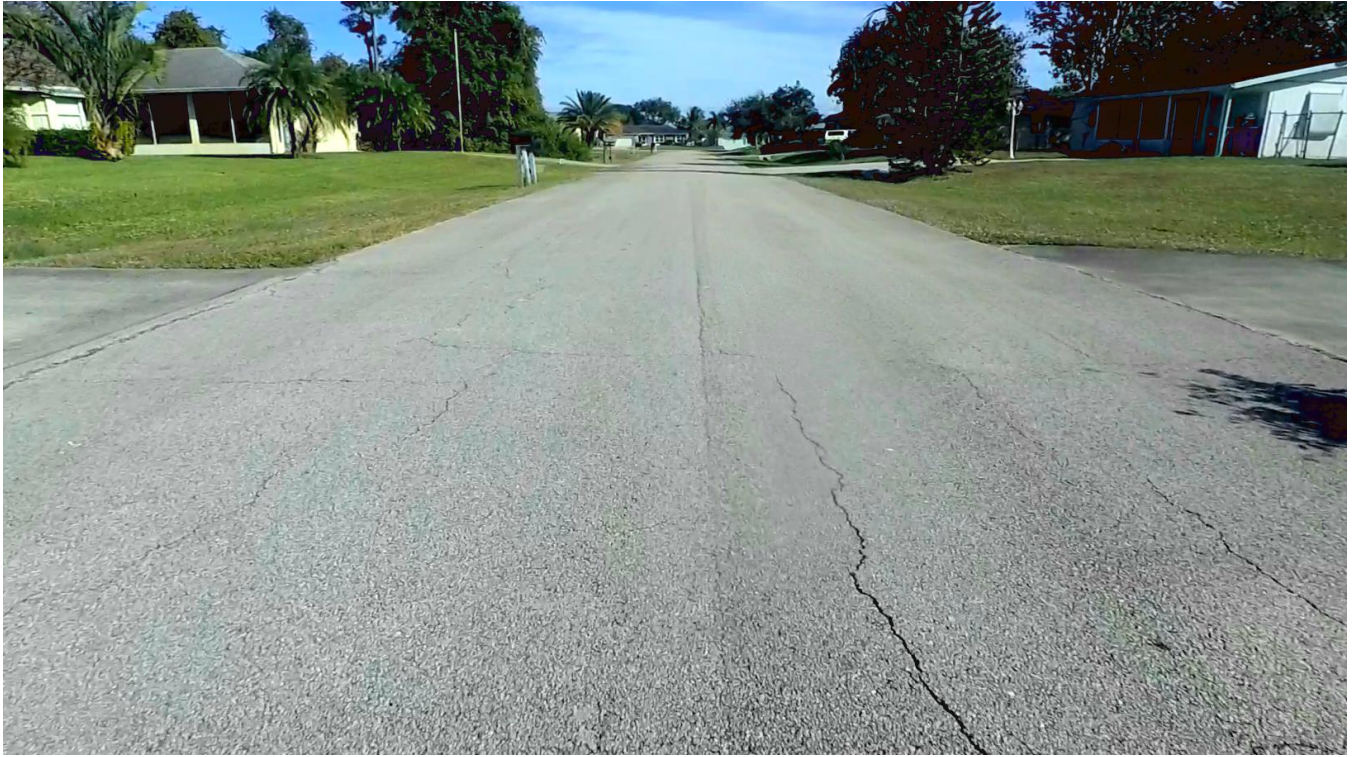
COLUMBIA AVE | SECTION 02 | PCI 71

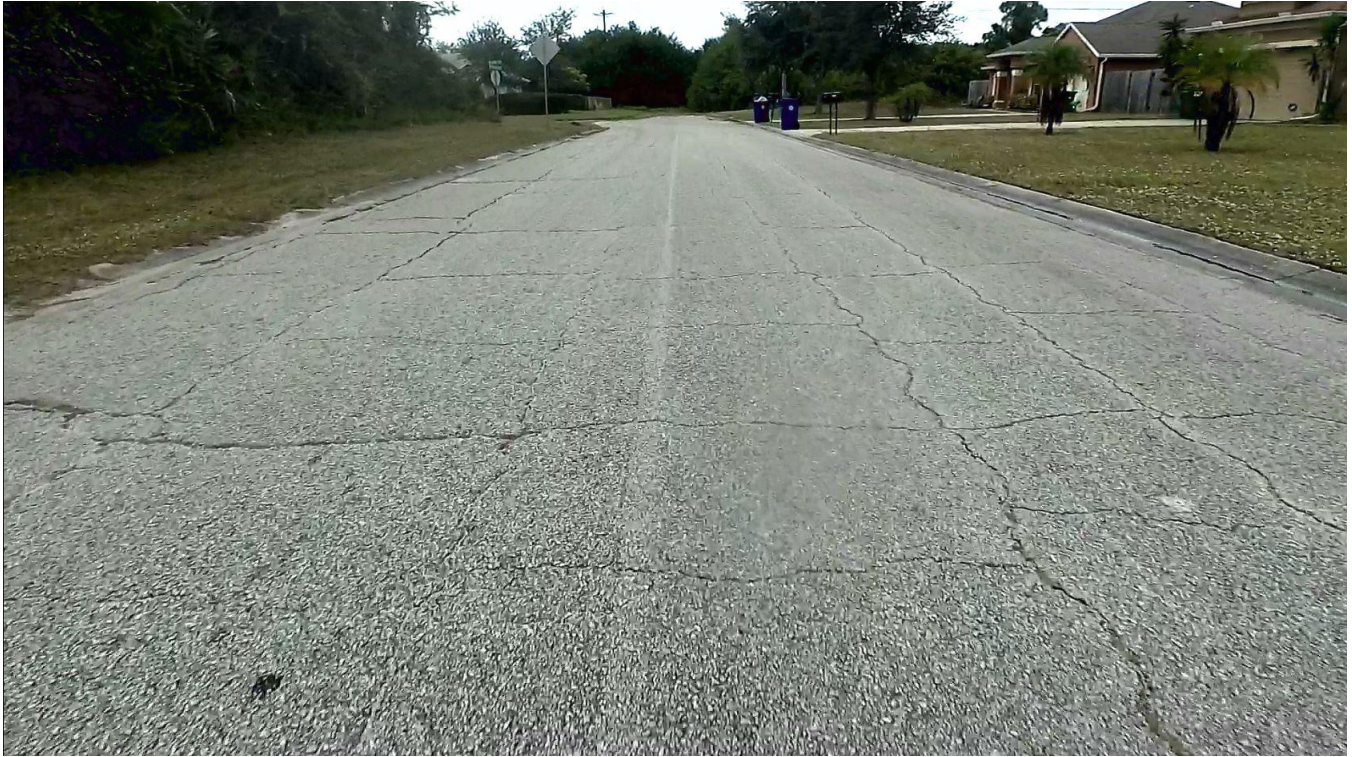
SPRING VALLEY AVE | SECTION 02 | PCI 55

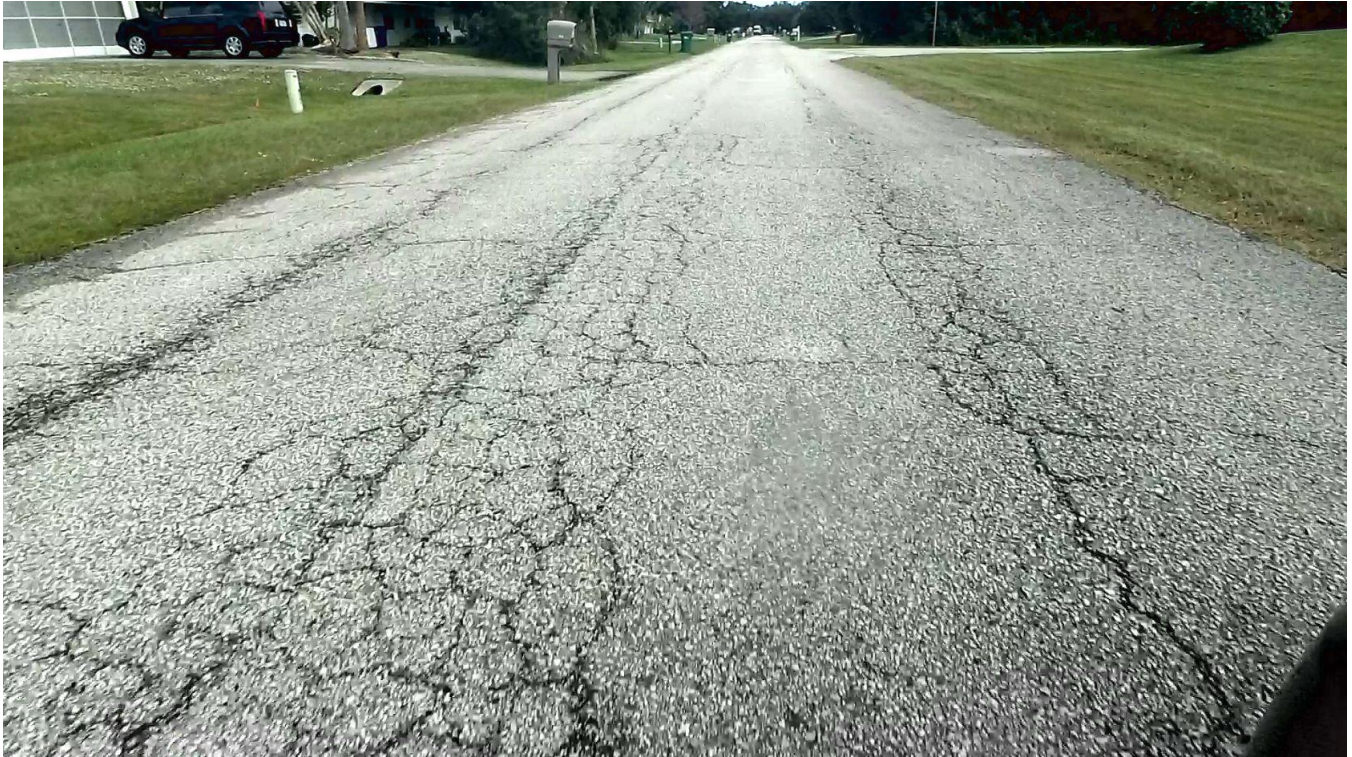
DOLPHIN AVE | SECTION 01 | PCI 38
