STORMWATER DEPARTMENT

**RECENT IPM-RELATED
MAINTENANCE
PROJECTS**

August 2020- February 2021

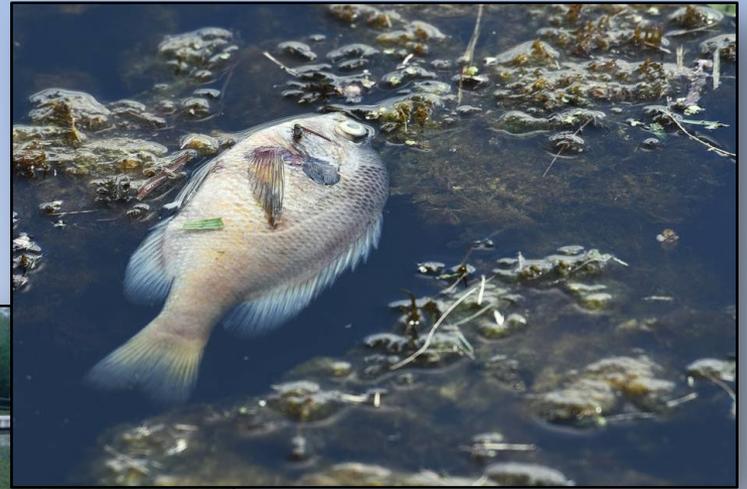
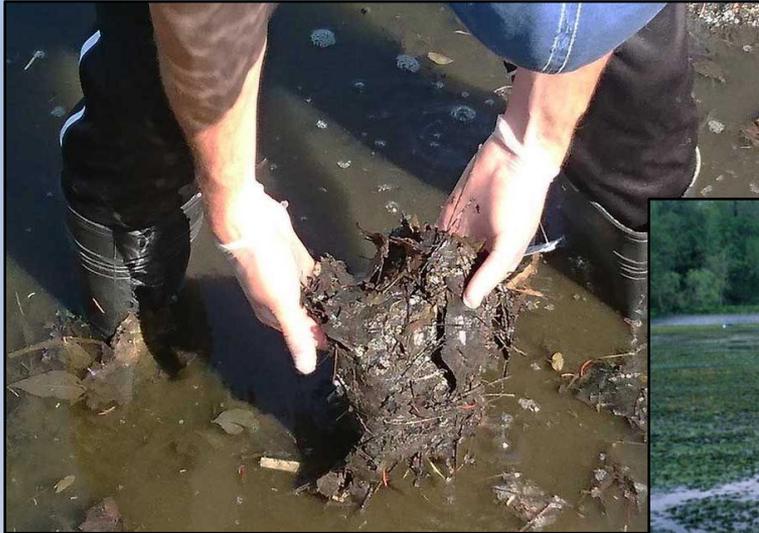
Reduces
dissolved
oxygen

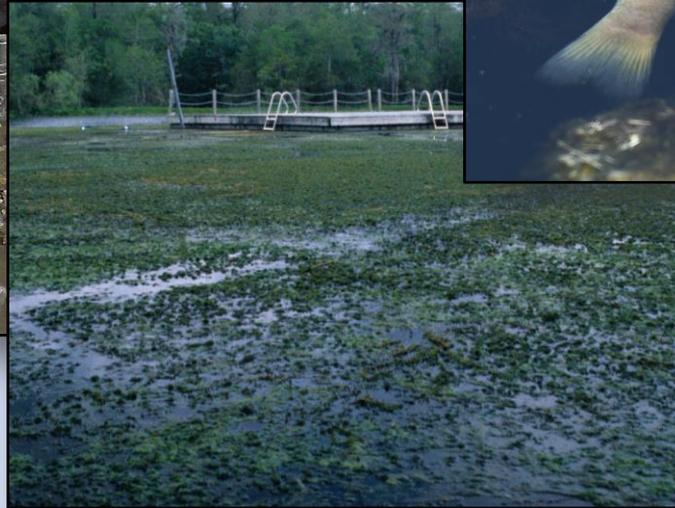
Increases
muck

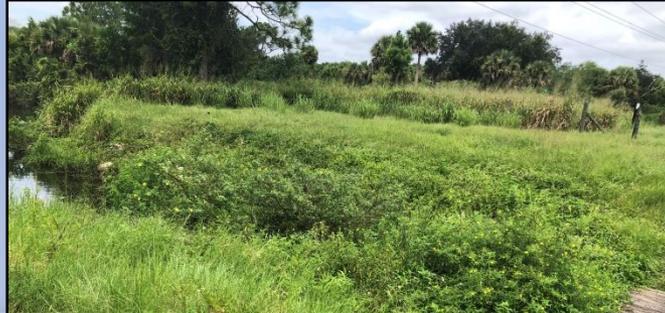
Impairs
water
flow

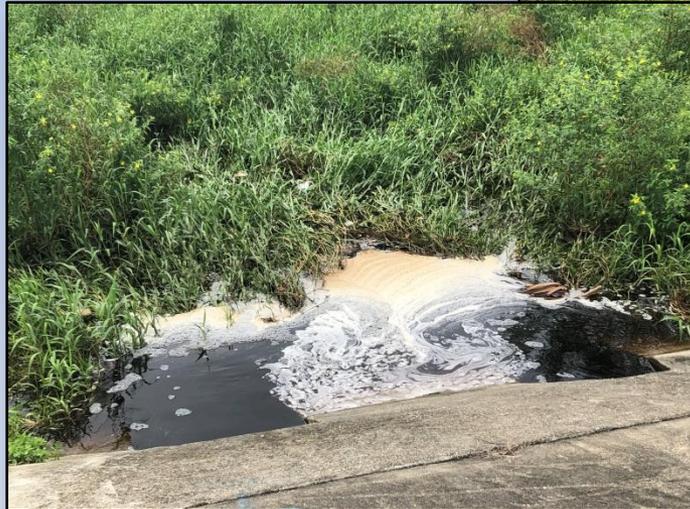
Reduces
storage
capacity

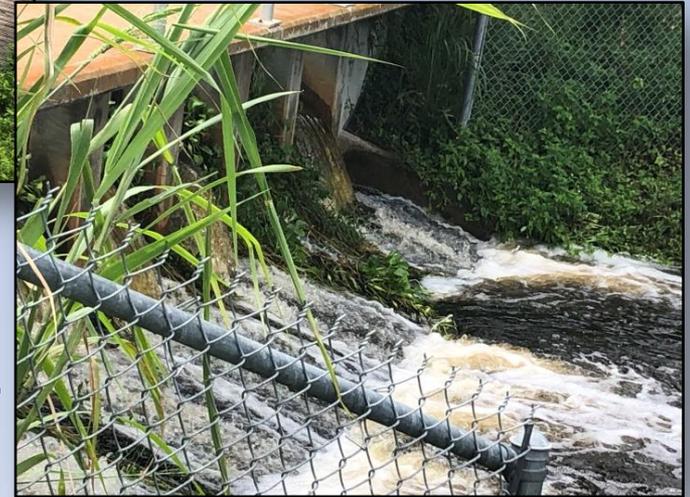
Damages
stormwater
structures

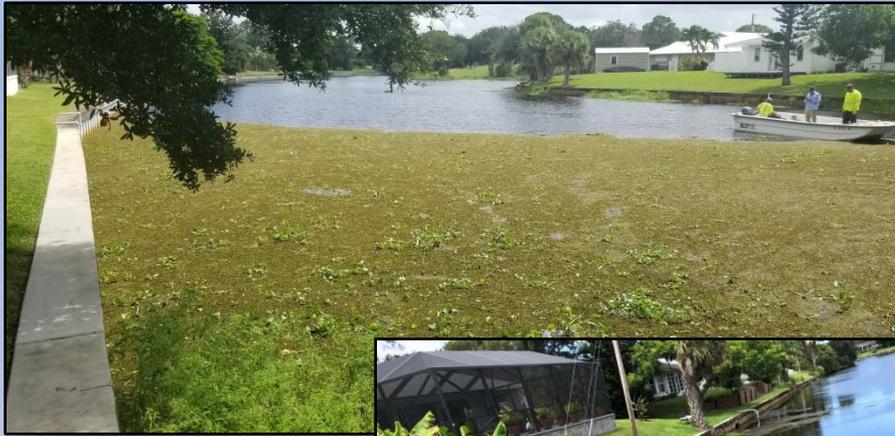
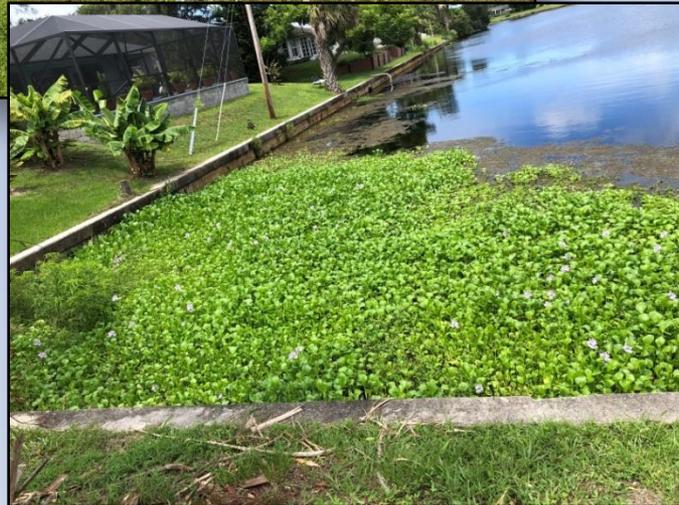
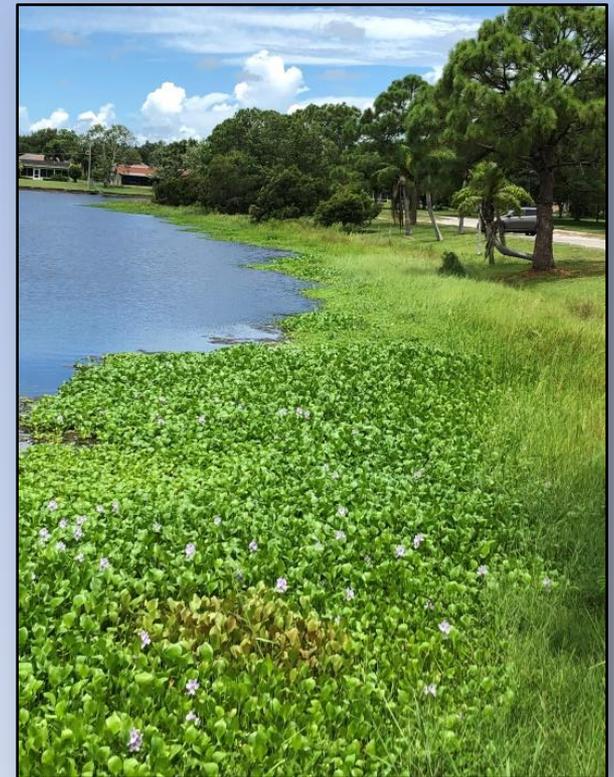
Hardee Park Canal Project

Invasive, fast-growing, vegetation forming dense mats

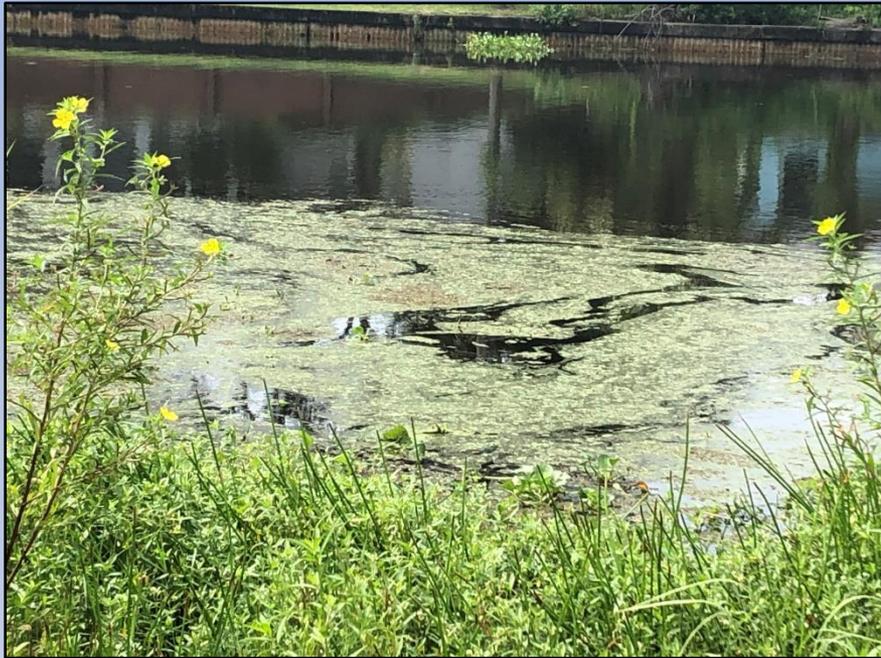
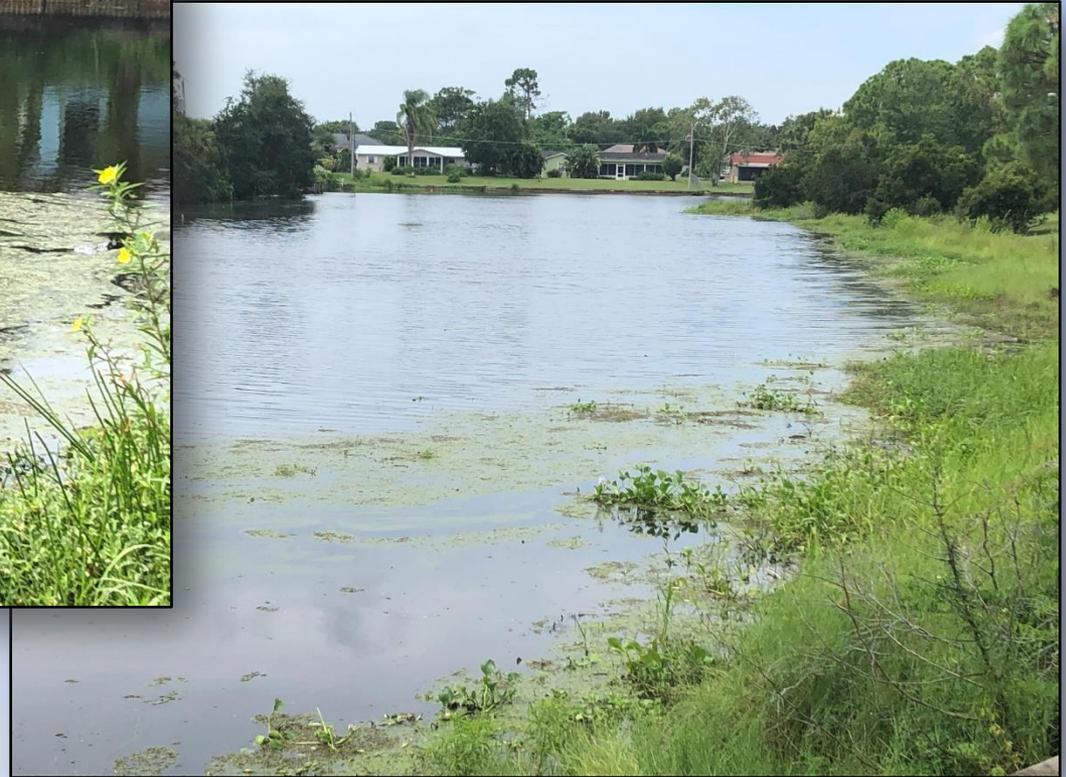
Hardee Park Canal Project

After 6 days, most of the vegetation- only at the canal terminus was removed, however, much of the duckweed remained.

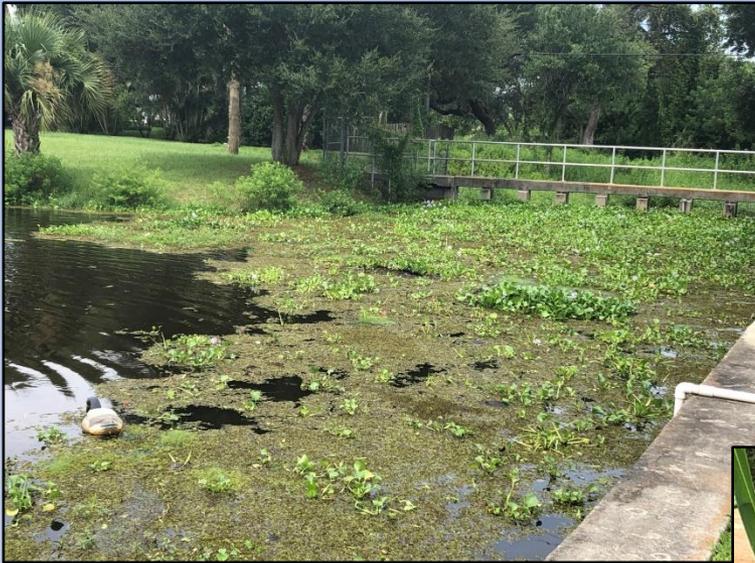
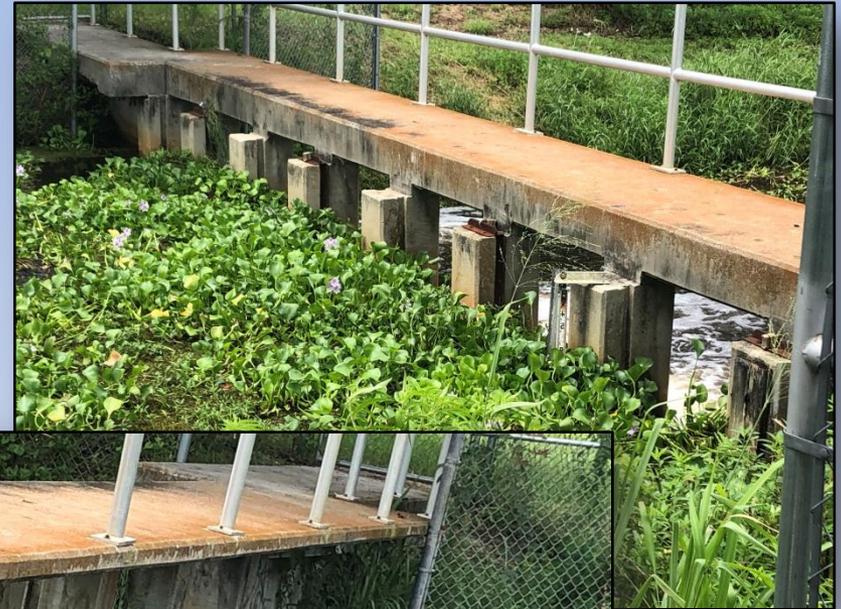
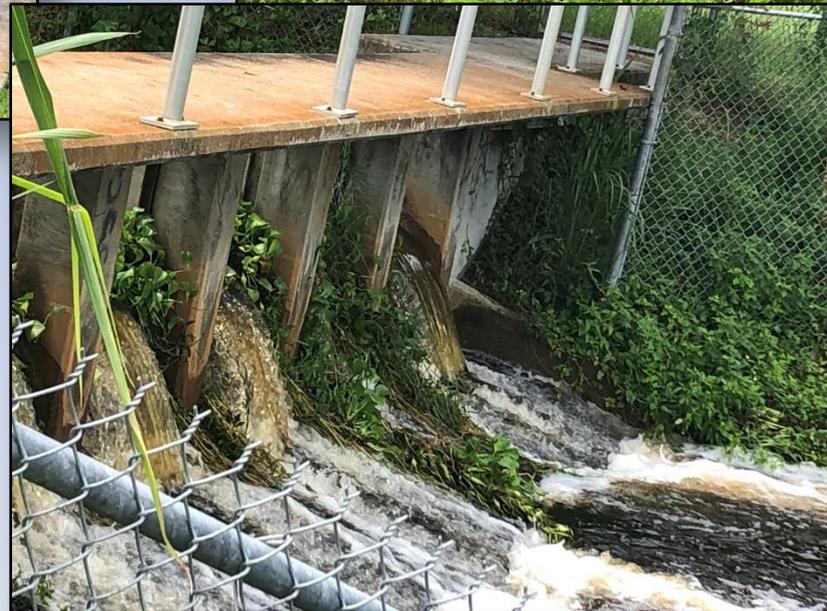
Hardee Park Canal Project

Just around the bend from the park, the vegetation gathered and flourished, blocking vital flow from the Hardee Dam

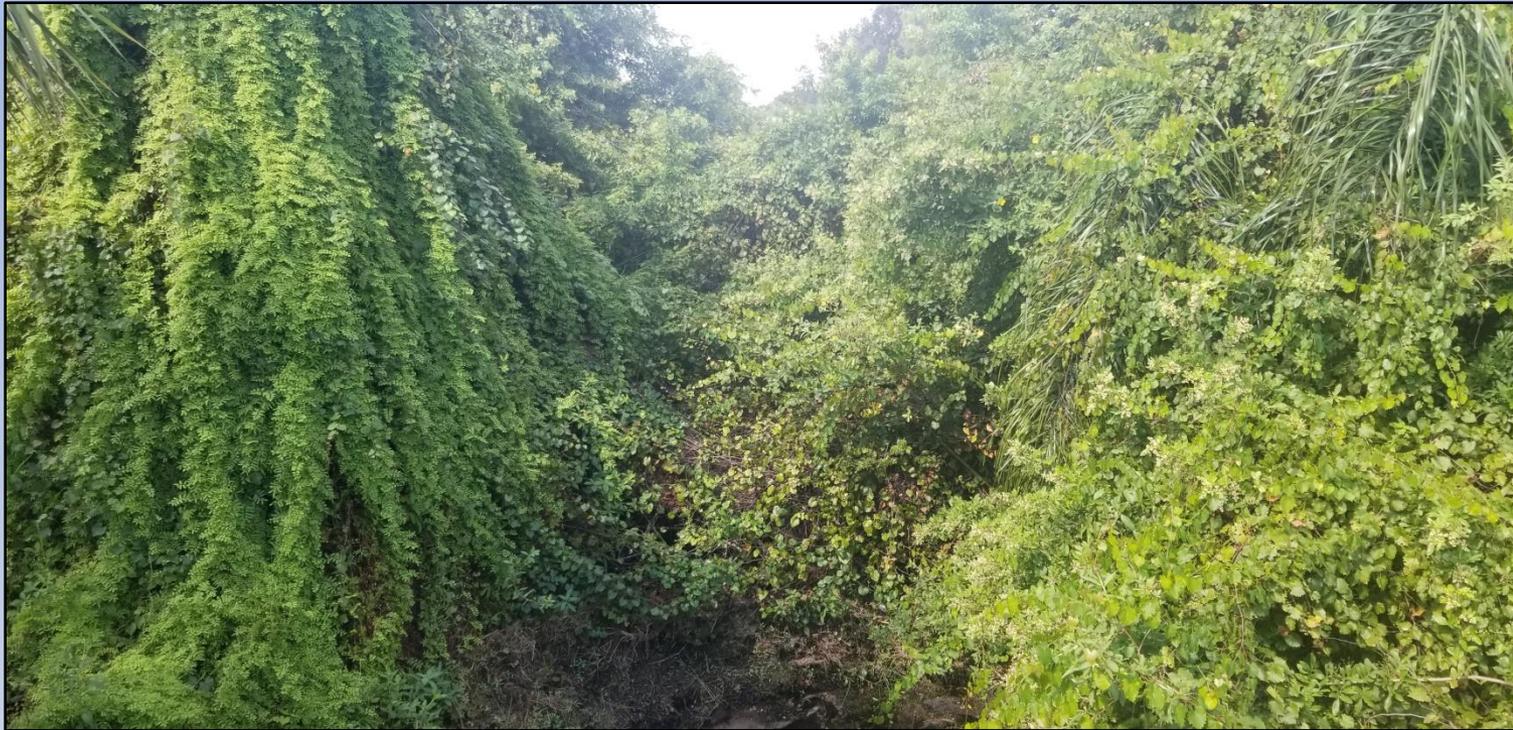
Collier Creek Canal

BEFORE:
Overgrown
with brush
and
invasive
vines,
ineffective
for storing
and moving
stormwater

Mechanical vegetation removal and bank re-grade project for the beginning of Collier Waterway, off South Easy Street.

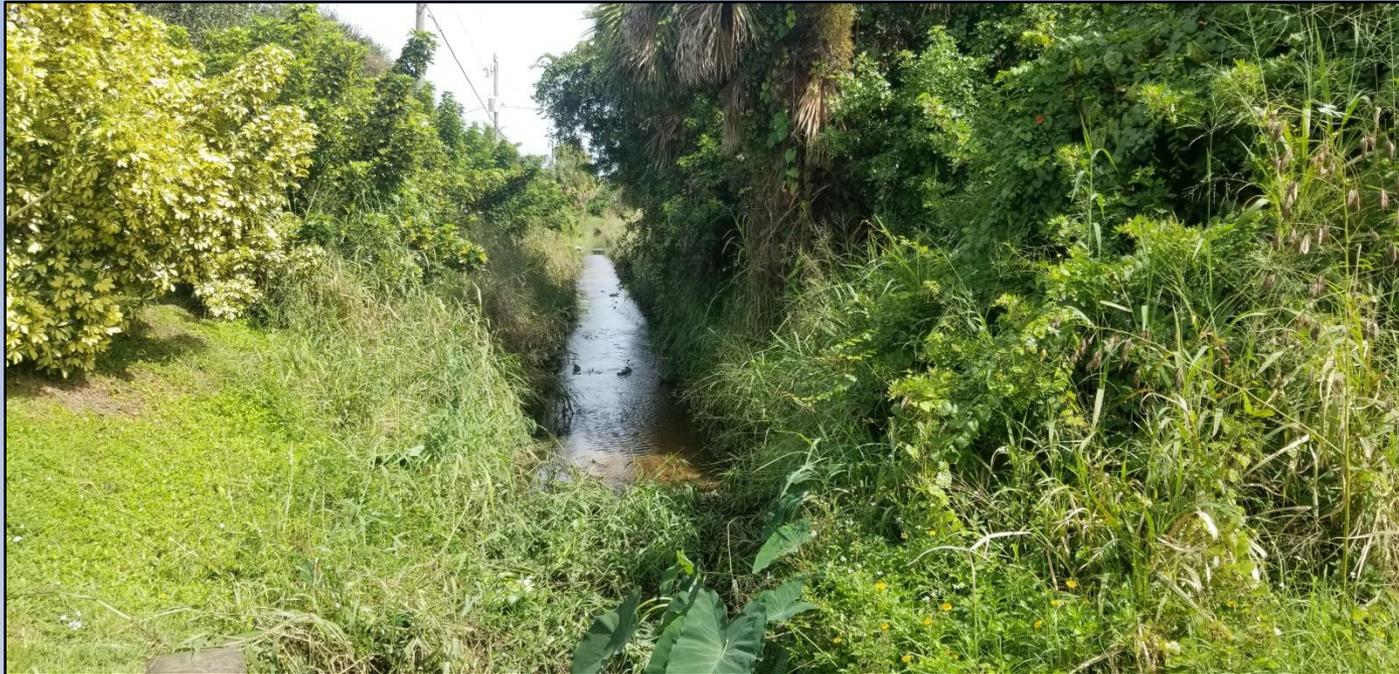
Tulip Drainage

The final result!

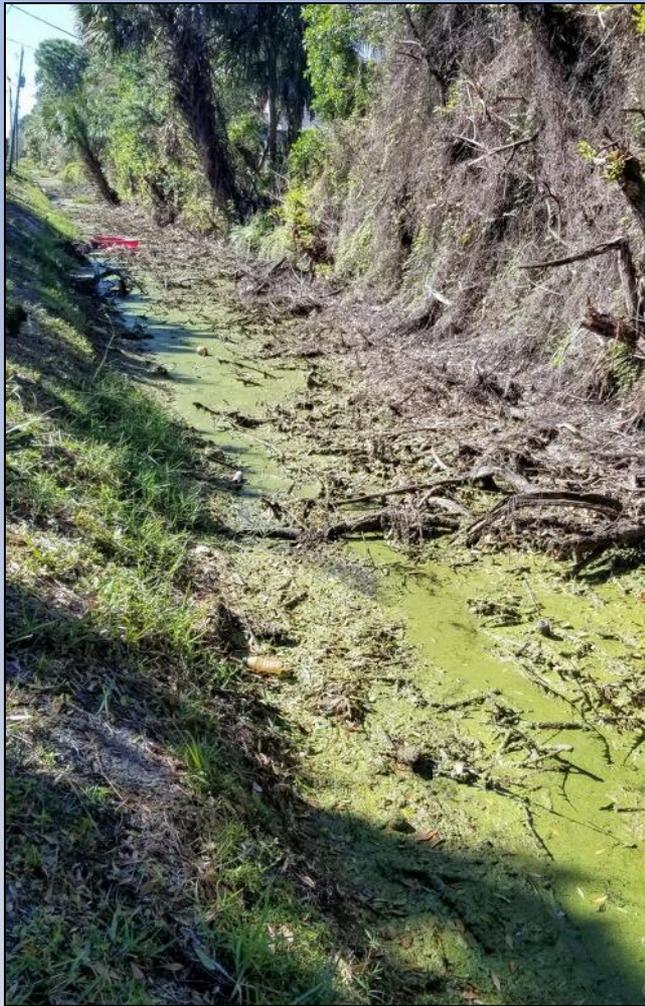
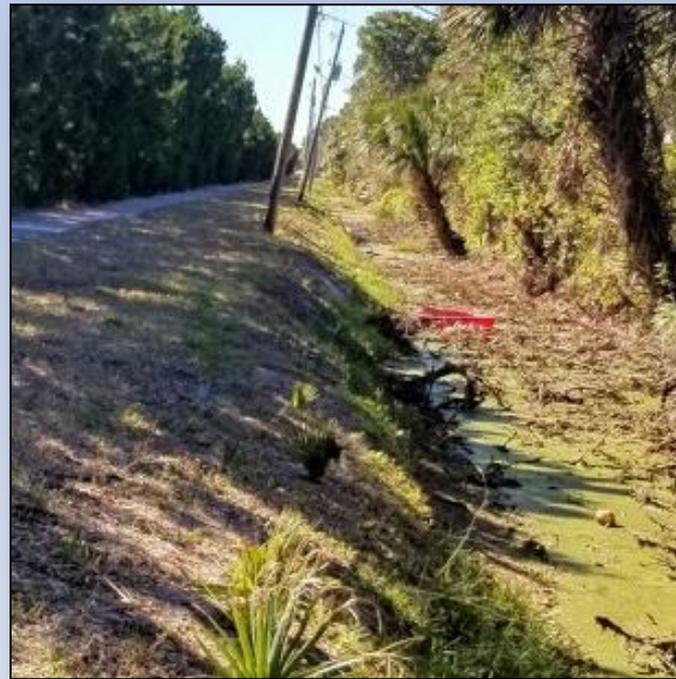
512 Drainage

Very little water was flowing through this main ditch, organic material and sediment deposits had made this ditch more of a swamp ideal for breeding mosquitos and algae

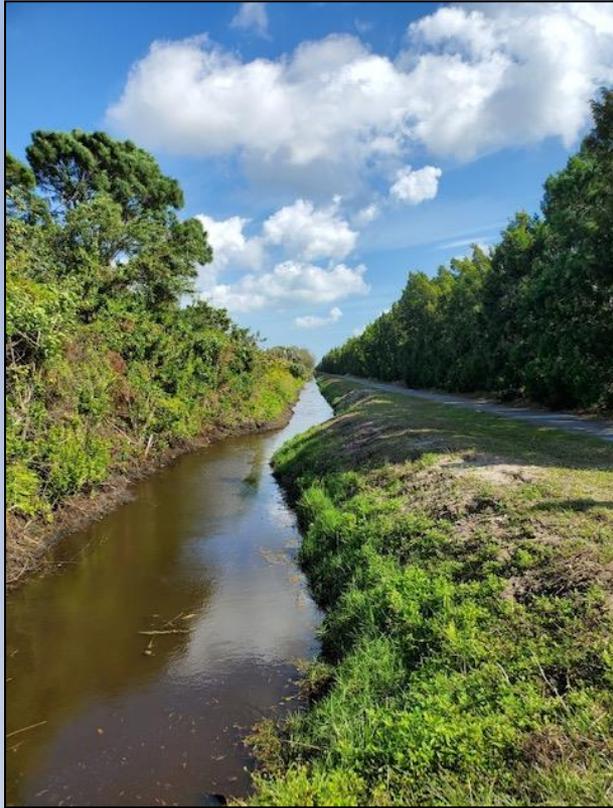
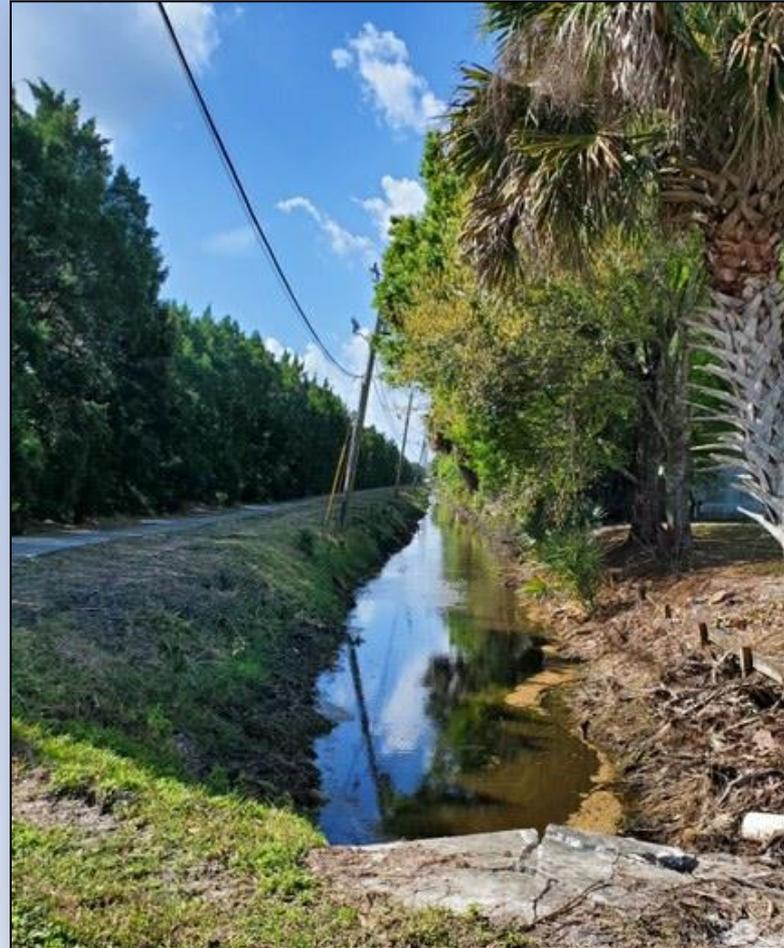
512 Drainage

The final result is an open, flowing channel, free of debris!
