Above the Flood: Elevating Your Floodprone House

FEMA 347 / May 2000

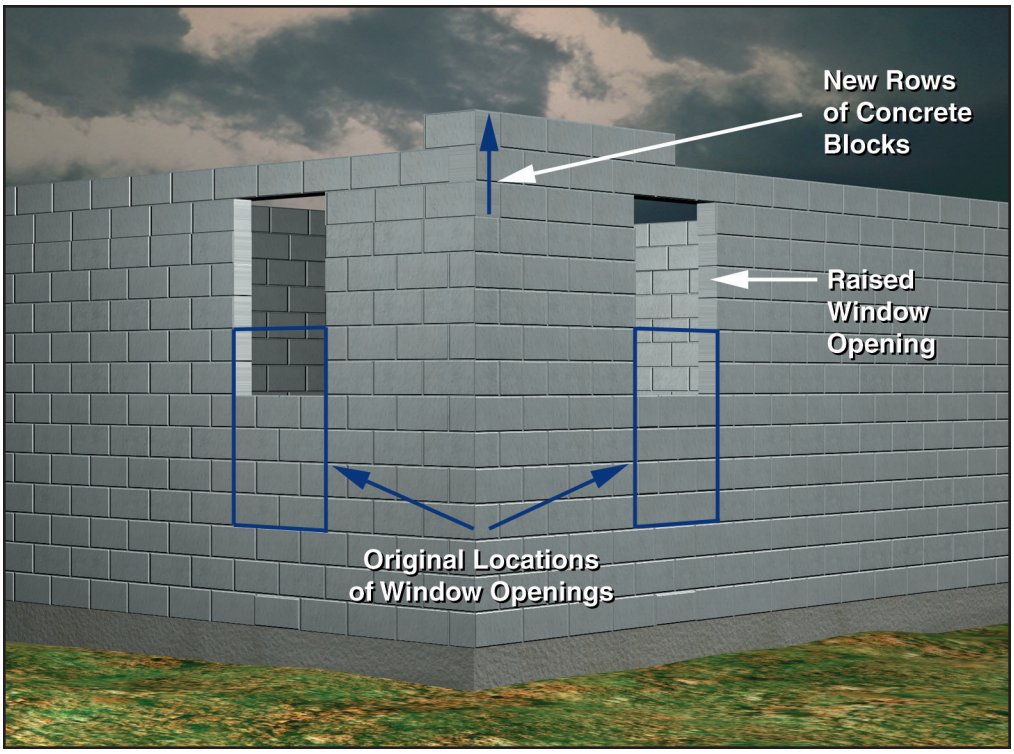
After the roof, windows, and doors are removed, several courses of concrete block are added to the tops of the existing walls and to the bottoms of the window openings (Figure 11). A corresponding number of blocks are removed from the tops of the window openings so that the size of the windows will remain the same. In addition, although not shown in Figure 11, concrete bond beams are formed in place at the tops of the extended walls to provide structural reinforcement.

Figure 11
The tops of the walls and bottoms of the window openings are raised with concrete blocks.

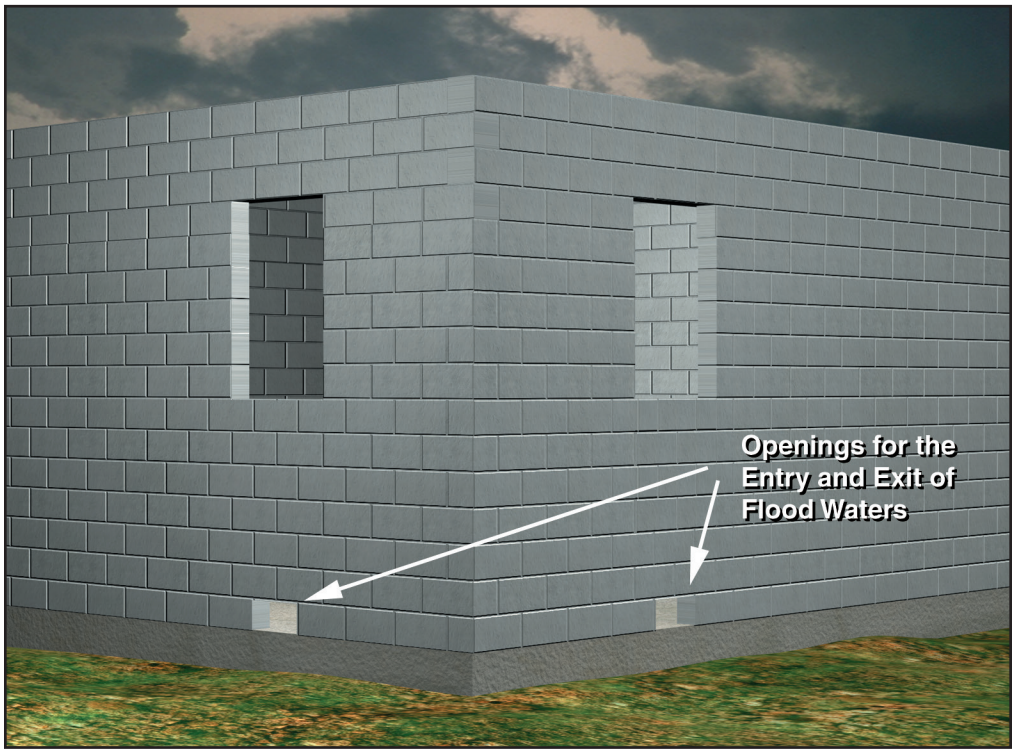
Blocks are removed from the walls of the house at selected locations within 1 foot of the ground (Figure 12). The resulting openings will allow flood waters to flow into and out of the lower area of the house so that the water pressures on both sides of the walls will remain the same. The roof and windows are then replaced, and a new wood-frame floor is constructed above the flood level (Figure 13).

Figure 12
Openings are created in the walls near the ground.

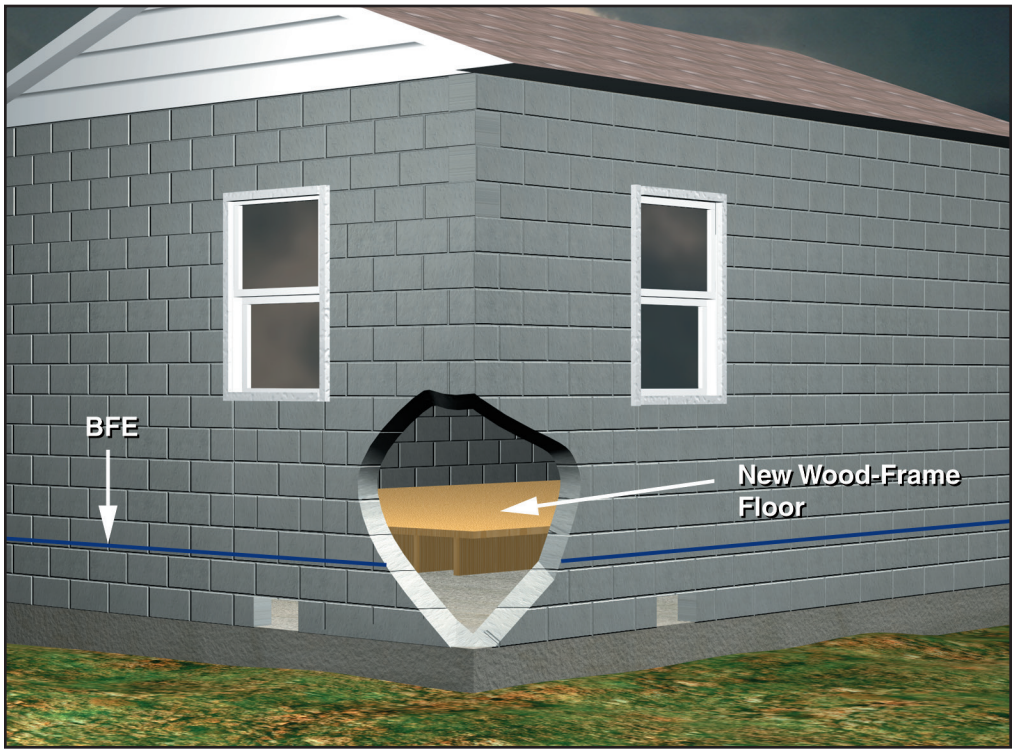
Figure 13
A new wood-frame lowest floor is constructed above the flood level, and the roof, windows, and doors are reinstalled.

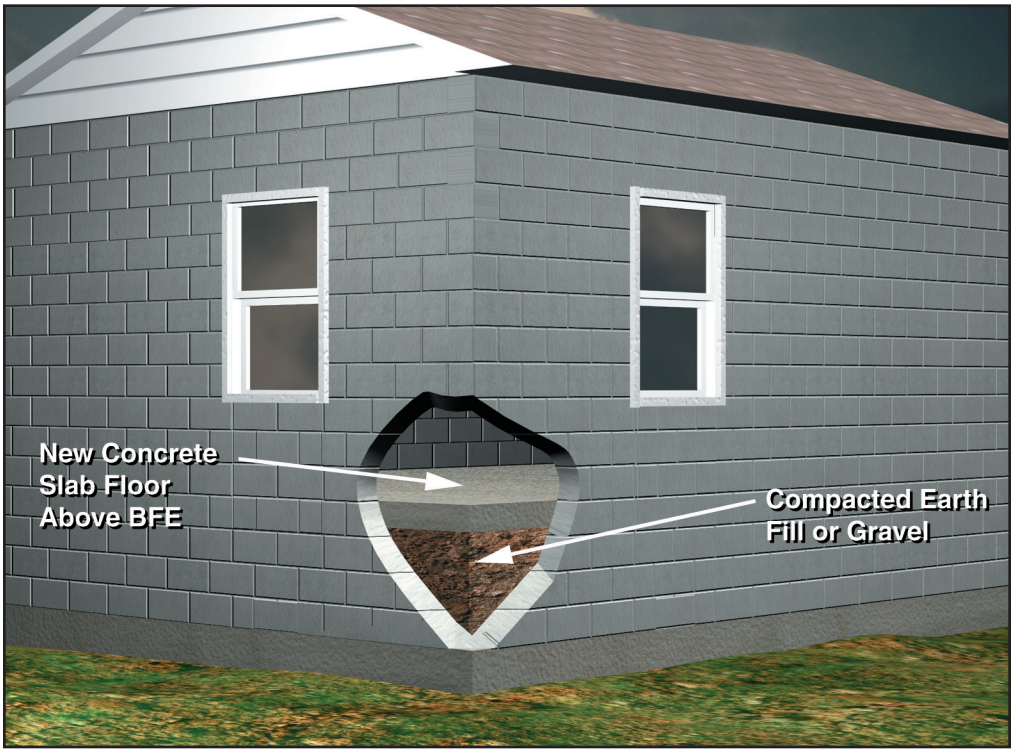
A homeowner who chooses Technique 1 may decide to build a new concrete slab floor instead of a wood floor (Figure 14). When this option is chosen, compacted fill dirt or gravel is placed on top of the old slab and the new slab floor is poured on top. Because the area below the new floor is filled with dirt or gravel, wall openings are not required.

Figure 14
An alternative to building an elevated wood-frame floor is installing a new, elevated concrete slab floor on fill placed over the old slab.

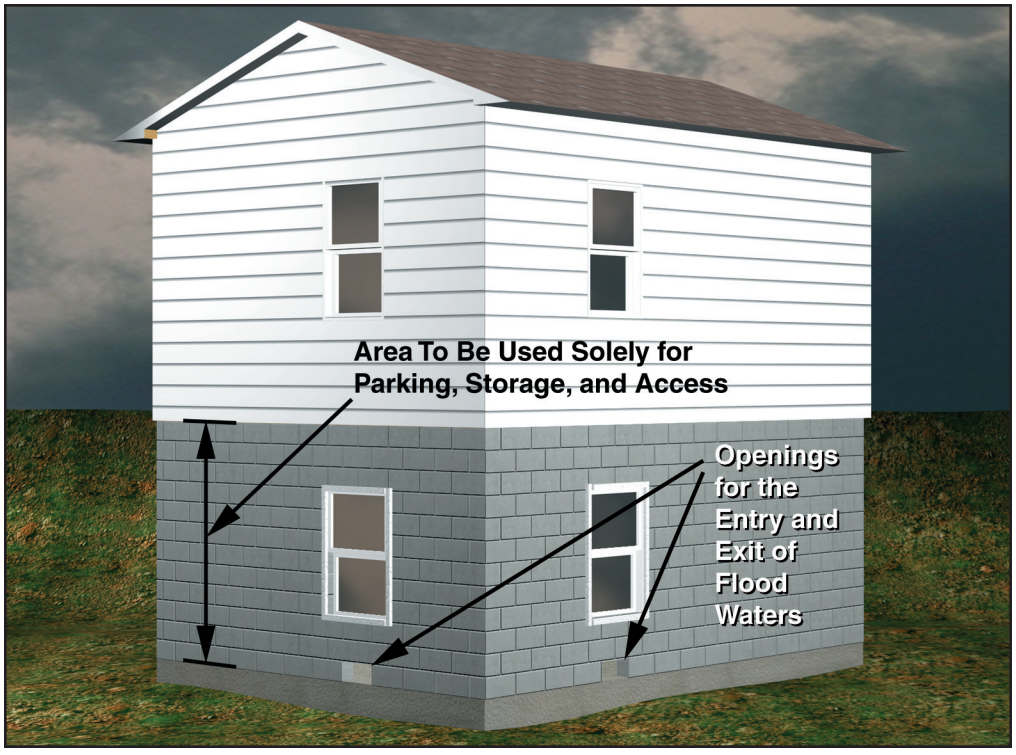
Some homeowners prefer that the second story be constructed of masonry, but wood- or metal-framing is more common, primarily because it is lighter and less expensive. The roof is replaced, and blocks are removed from the walls to allow flood waters to enter and exit. Exterior sheathing is then added to the framed walls of the second story, the new windows are installed, and siding or stucco is applied to the sheathing (Figure 16).

Figure 16
The new second-story walls are covered with siding or stucco.

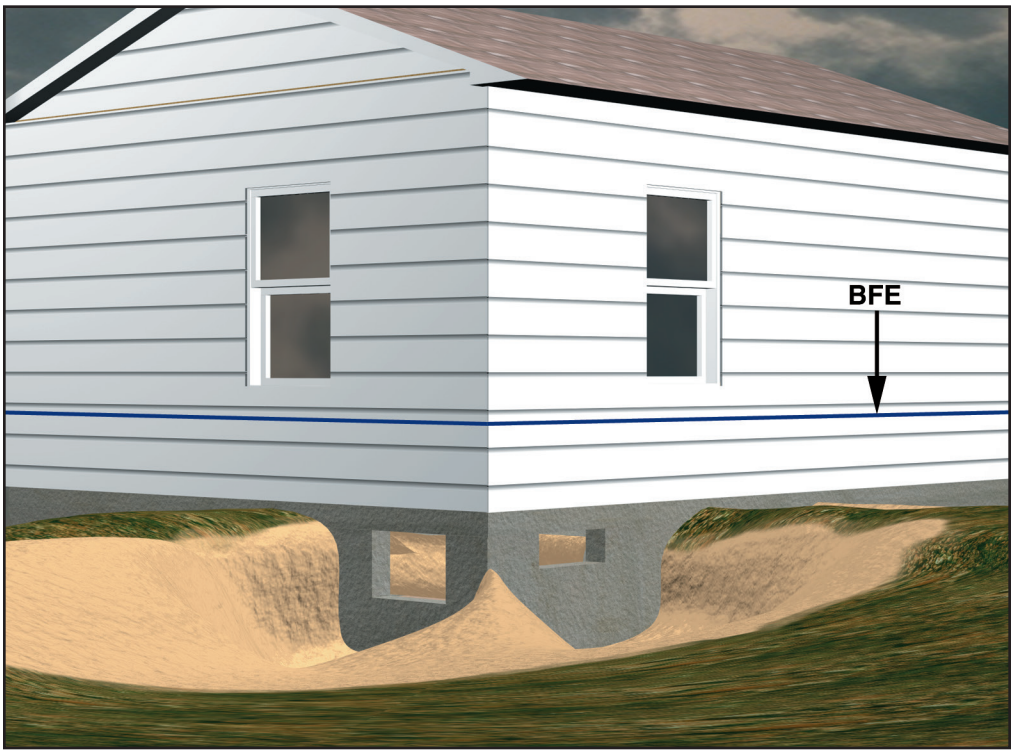
First, trenches are dug to expose the foundation walls immediately below the slab. Holes are then cut in the foundation walls at intervals around the house, and tunnels are dug under the slab (Figure 17). Jacks are placed in the trenches and large I-beams are inserted through the tunnels and allowed to rest on the jacks. Smaller I-beams are then inserted through the tunnels at right angles to the larger beams and positioned on top of them. The smaller beams support the slab when the house is raised (Figure 18).

Figure 17
Trenches and tunnels under the slab provide access for the jacks and I-beams that will lift the house.

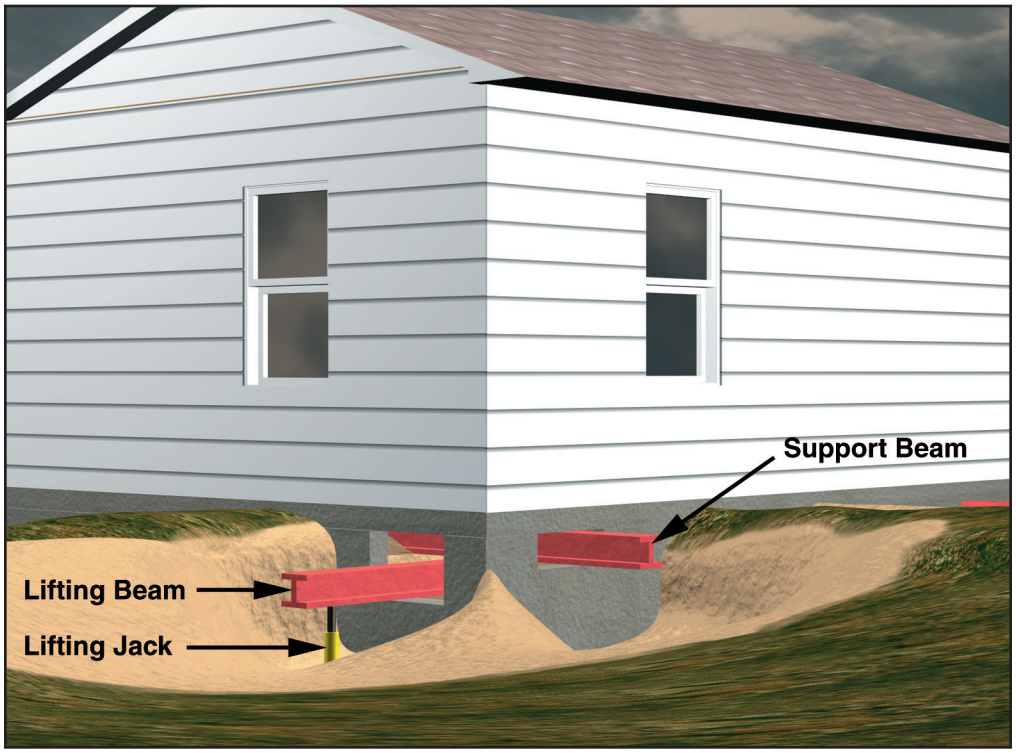
Figure 18
With I-beams and jacks in place, the house is ready to be lifted.

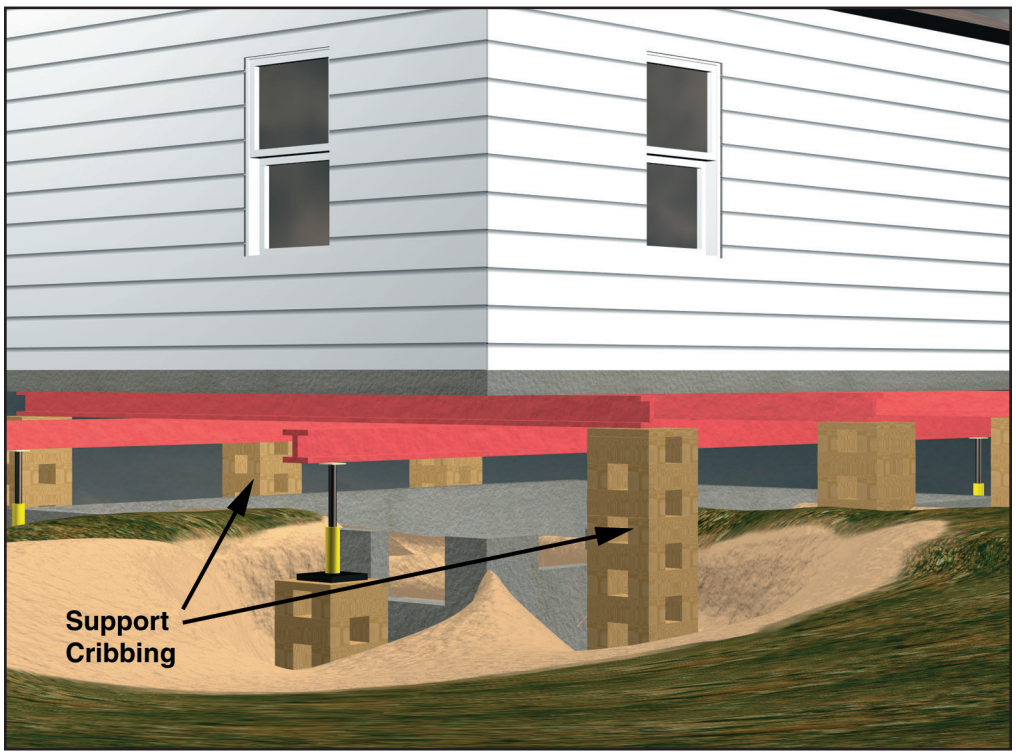
The house is then jacked up. When the jacks have extended as far as possible, the house must be supported temporarily while the jacks are raised. Both the house and the jacks are usually supported on "cribbing"—temporary piles of crisscrossed timbers (Figure 19). The jacks are then used to raise the house higher.

Figure 19
The house is temporarily supported on cribbing.

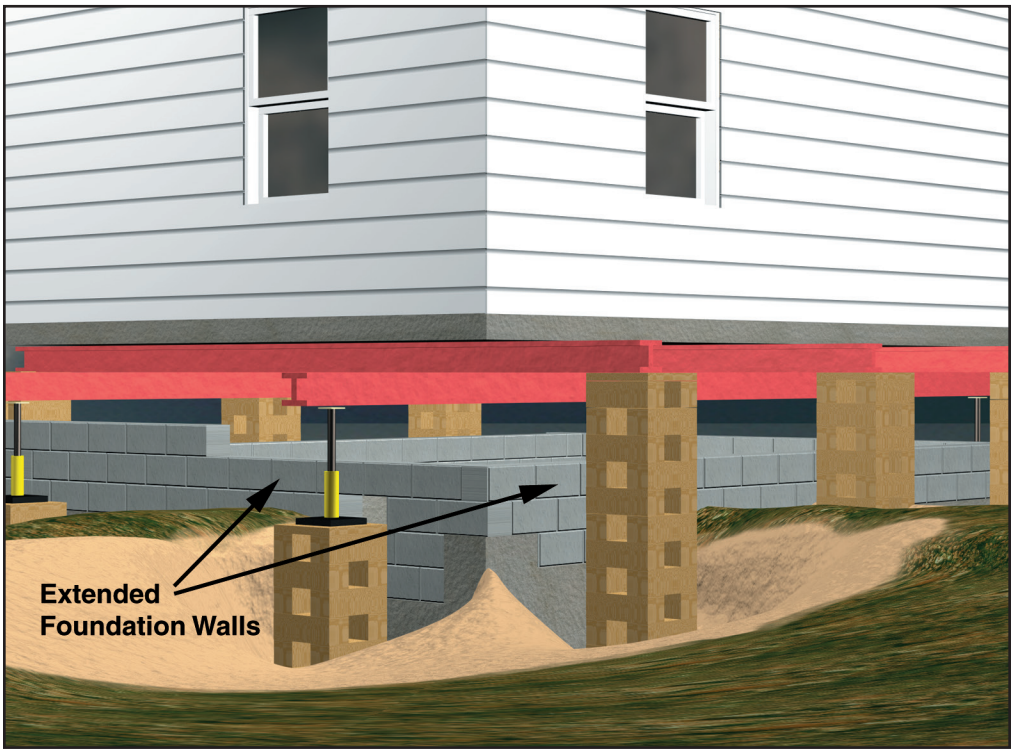
This process is repeated until the house is raised to the desired height. The foundation walls are then extended upward with additional rows of concrete block (Figure 20). As in the previous techniques, openings are made in the walls within 1 foot of the ground so that flood waters will be able to flow into and out of the area below the elevated floor. The jacks and beams are removed, and the openings left around the beams are filled with blocks (Figure 21).

Figure 20
New, extended foundation walls are constructed with concrete blocks.

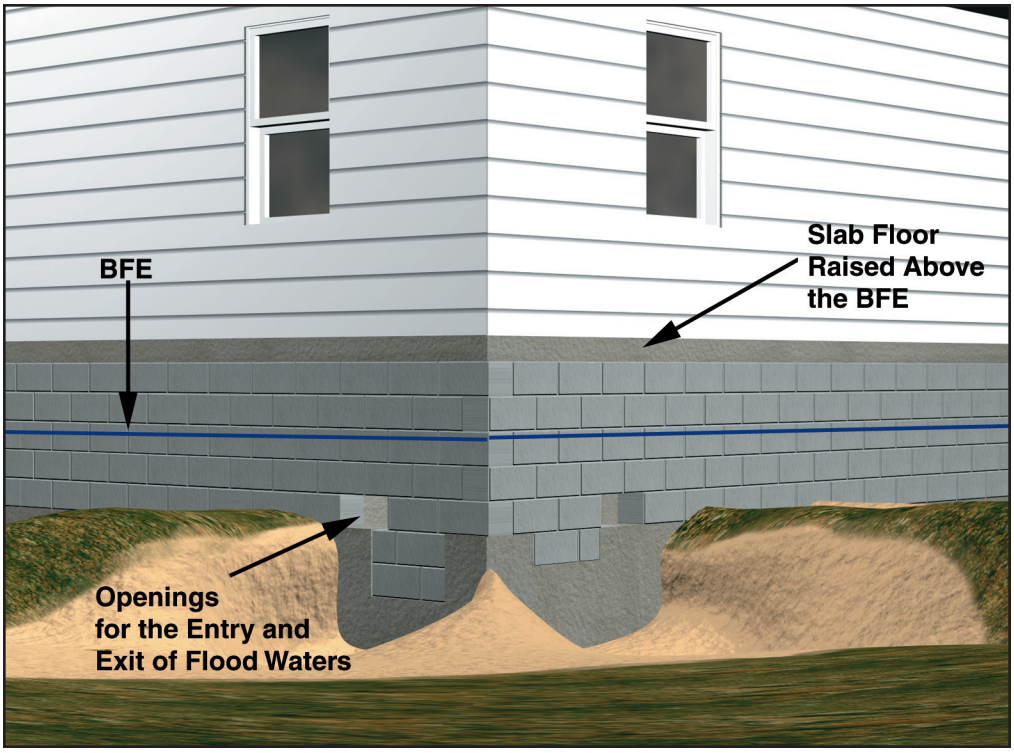
Figure 21
Elevated house and slab on new, extended foundation walls.

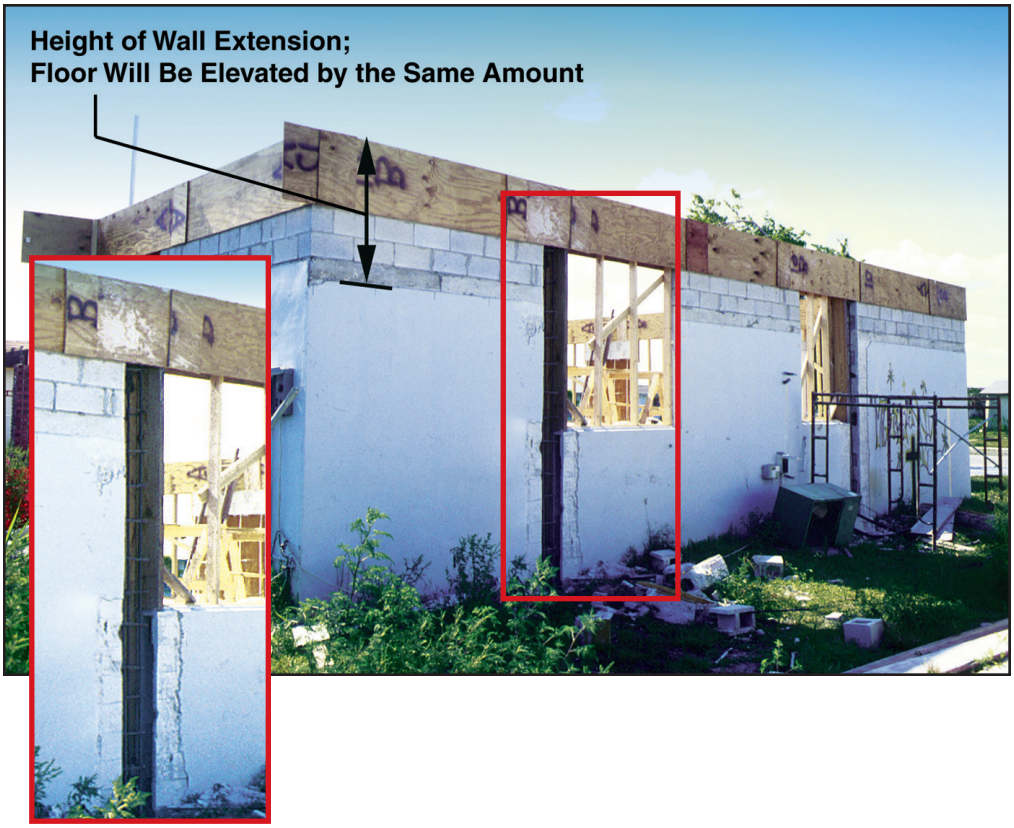
Figure 24
Another view of the extended walls. The vertical cuts in the walls next to the windows are for concrete tiedown columns that will be cast in place to further strengthen the extended walls against wind loads. The owner of this house was able to meet the elevation requirement by raising the floor only a few feet, as indicated by the amount that the walls have been extended.

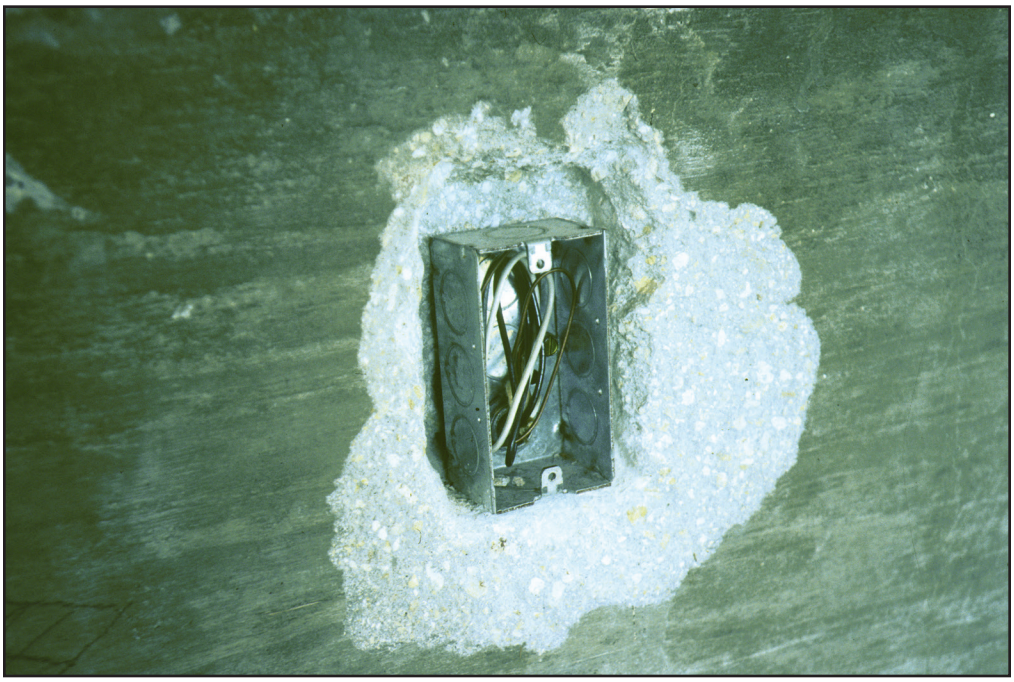
Figure 35
The electrical system is upgraded to meet current code requirements.

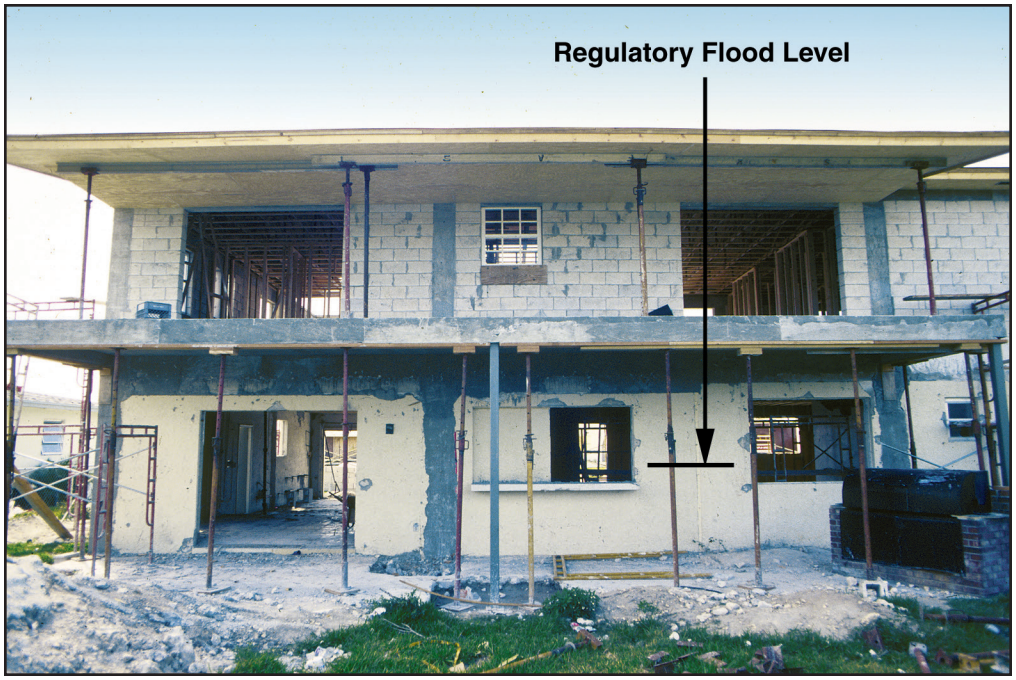
Figure 49
The house nears completion.

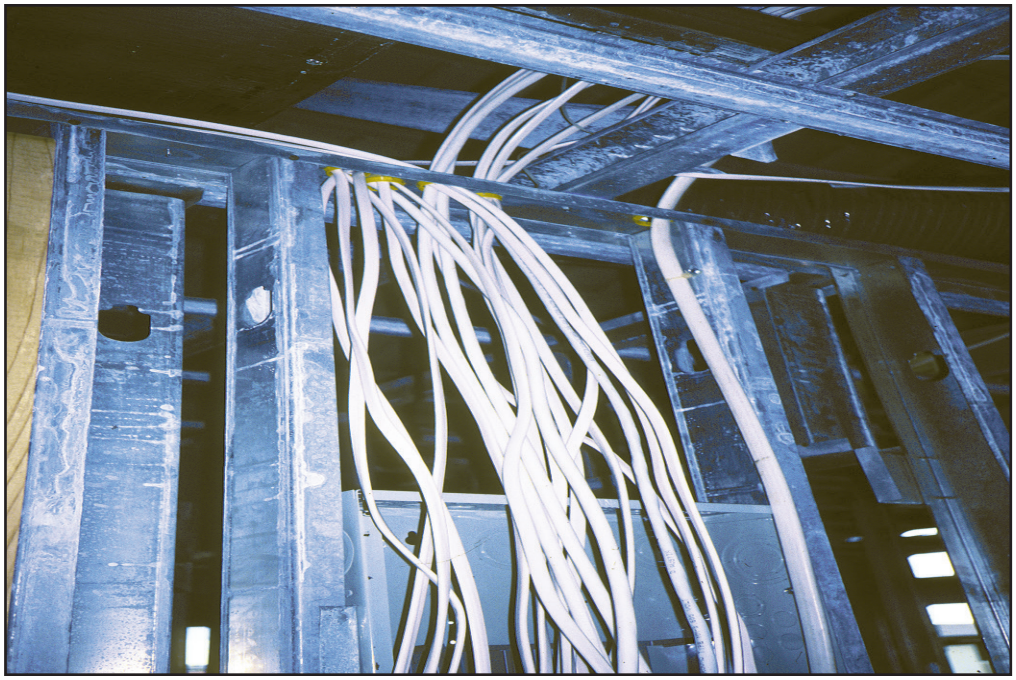
Figure 57
The project progresses with wiring and other utility work. As in each of the other house elevation projects, all current building code requirements must be met.

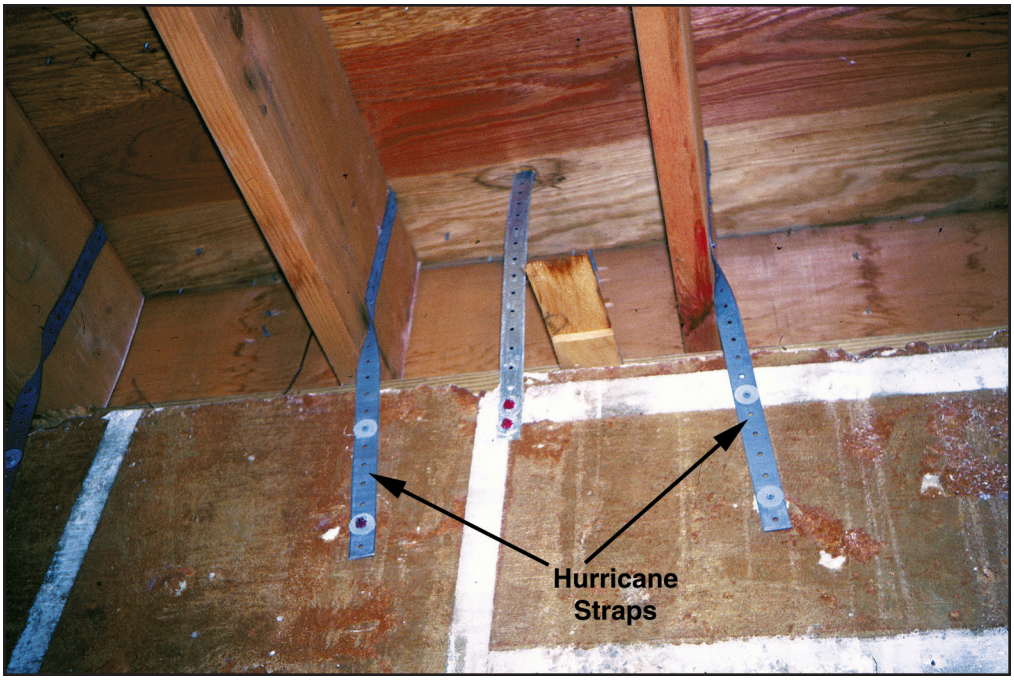
Figure 63
The new second-story walls are securely connected to the original first-floor walls with galvanized metal hurricane straps.

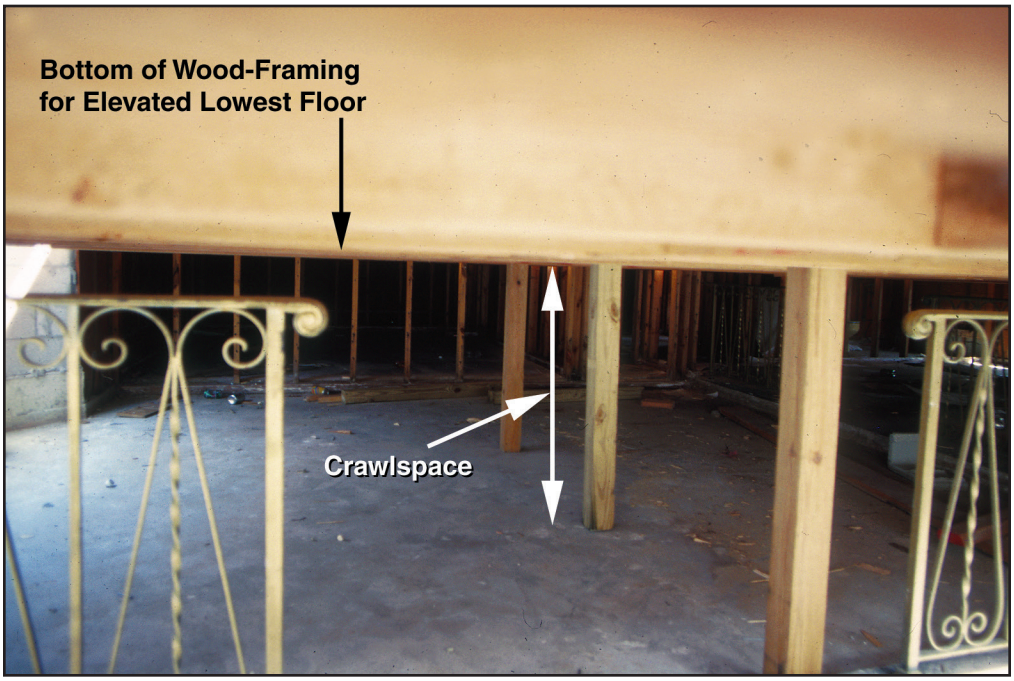
Figure 68
Rather than install a new concrete slab on compacted fill, the owner of this house chose to build a new wood-frame floor above the old concrete slab. This method creates a crawlspace below the new floor.

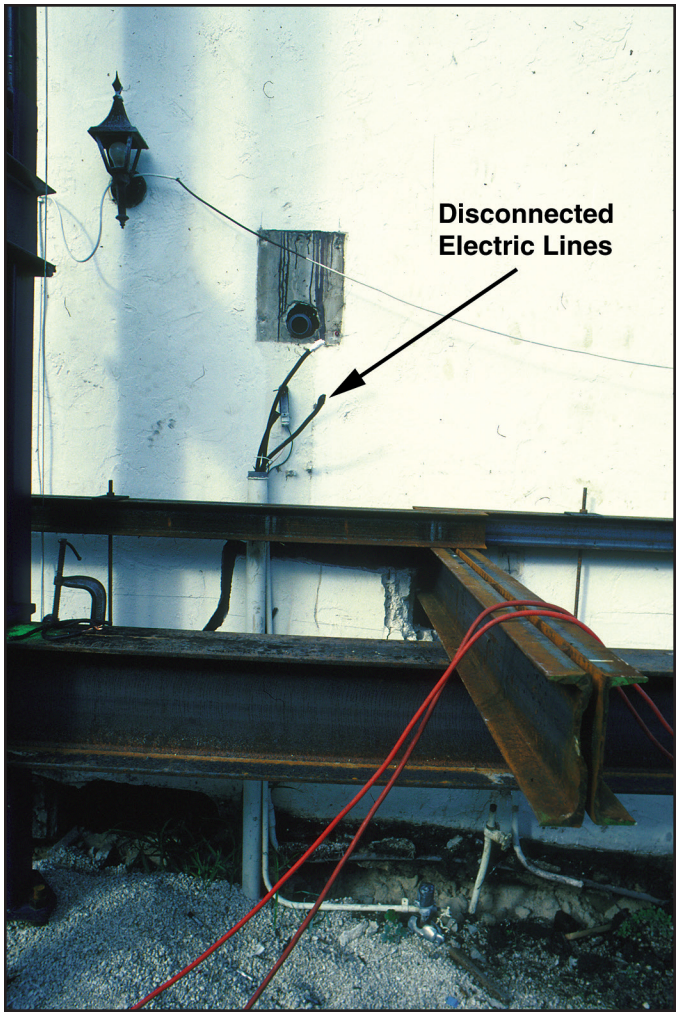
Figure 75
Electrical lines and other utilities were disconnected early in the project.

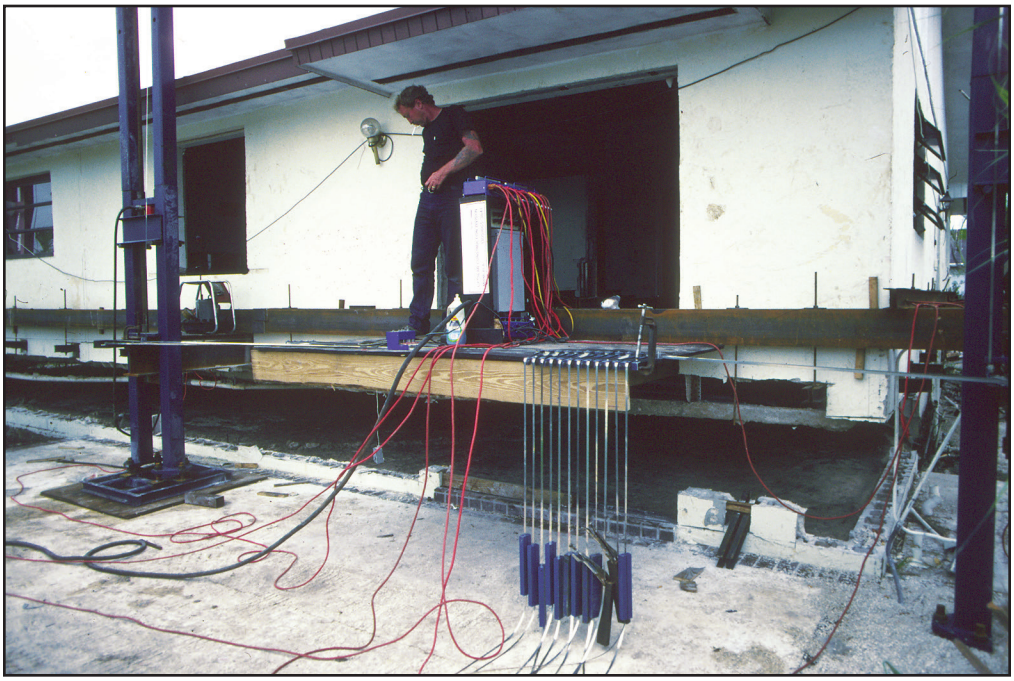
Figure 80
Lifting the house, while simple in theory, is complicated by the need to ensure an equal amount of lift at each jack throughout the process. Too much or too little lift at even one jack can cause the slab and walls to crack. The elevation contractor for this project used a sophisticated jacking system that provided the required level of control.
