# PAVEMENT MANAGEMENT FINAL PROJECT REPORT

**CITY OF SEBASTIAN, OH**

**Tuesday, January 08, 2019**

**Pavement Management Group**

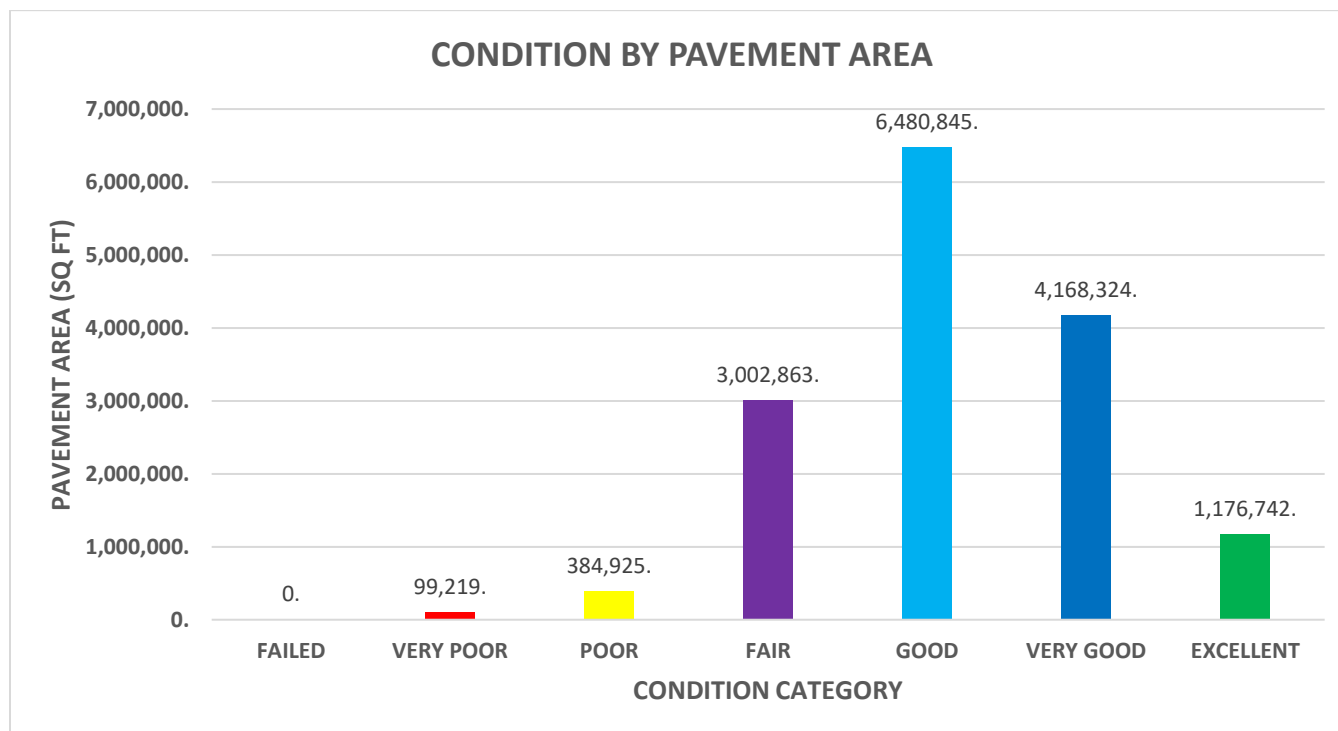
Figure 3. Pavement Area by Condition Category

After completion of the 2018 pavement management project, PMG has determined that the average PCI for the City of Sebastian's 290 lane mile (148 Centerline Mile) street network is a 75 and considered to be in Good condition. Table 2 displays the condition summary data by category across the network while Figures 3, 4, and 5 further illustrate the condition breakdown in graph form. A complete Inventory and Condition Report in Excel spreadsheet was provided as a part of this project deliverable.

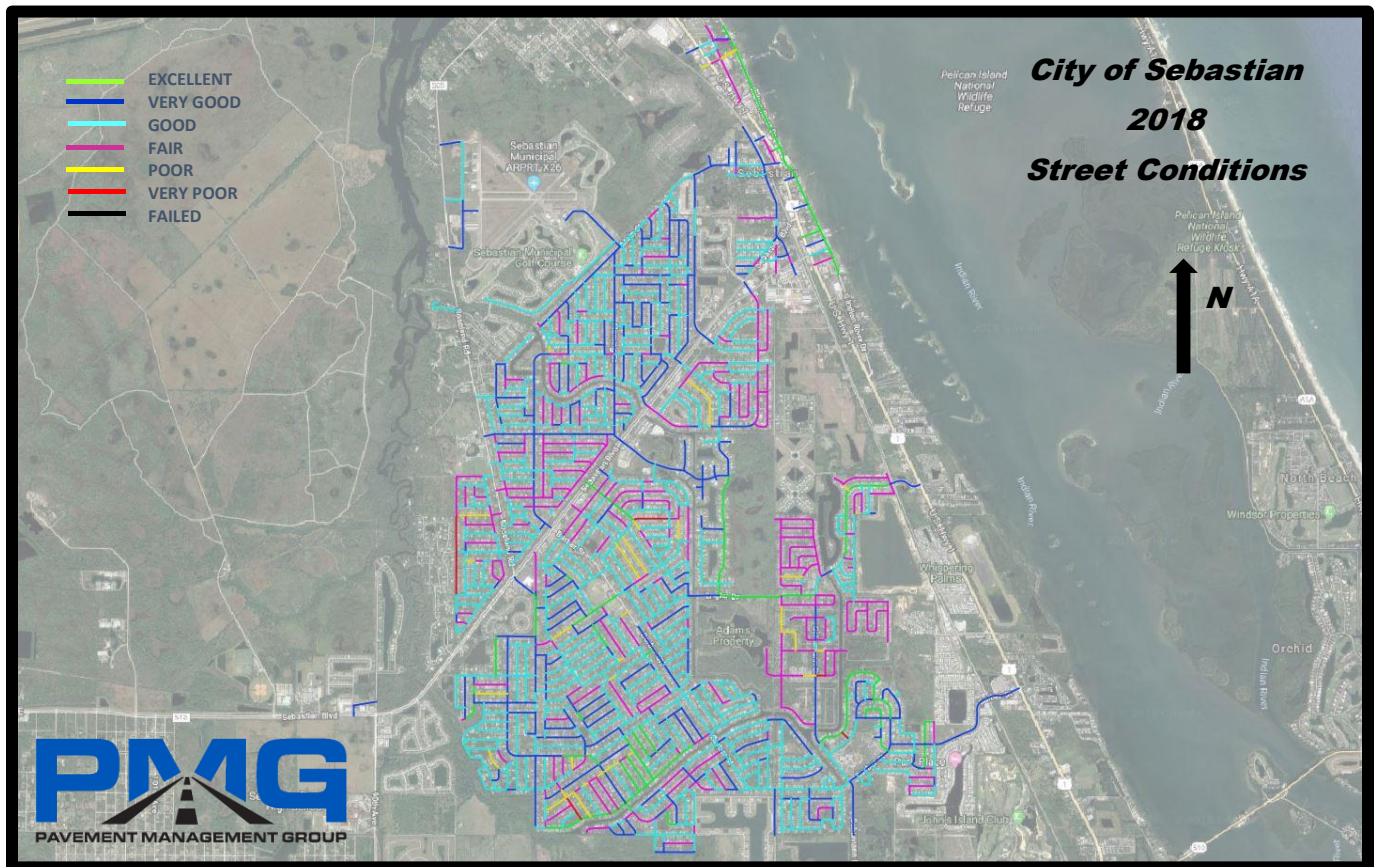
Figure 6. Street Section Latest Condition maps

PMG assigned all pavement management data to GIS and will provide the shapefile to the agency. This allows for a wide variety of mapping options within both ESRI's ArcGIS and Google Earth. The following shows an example of a Latest Condition Map that has been created in both GIS and Google Earth for illustrative purposes. A 22 x 34 plot ready pdf version has been provided as a part of the project deliverable.

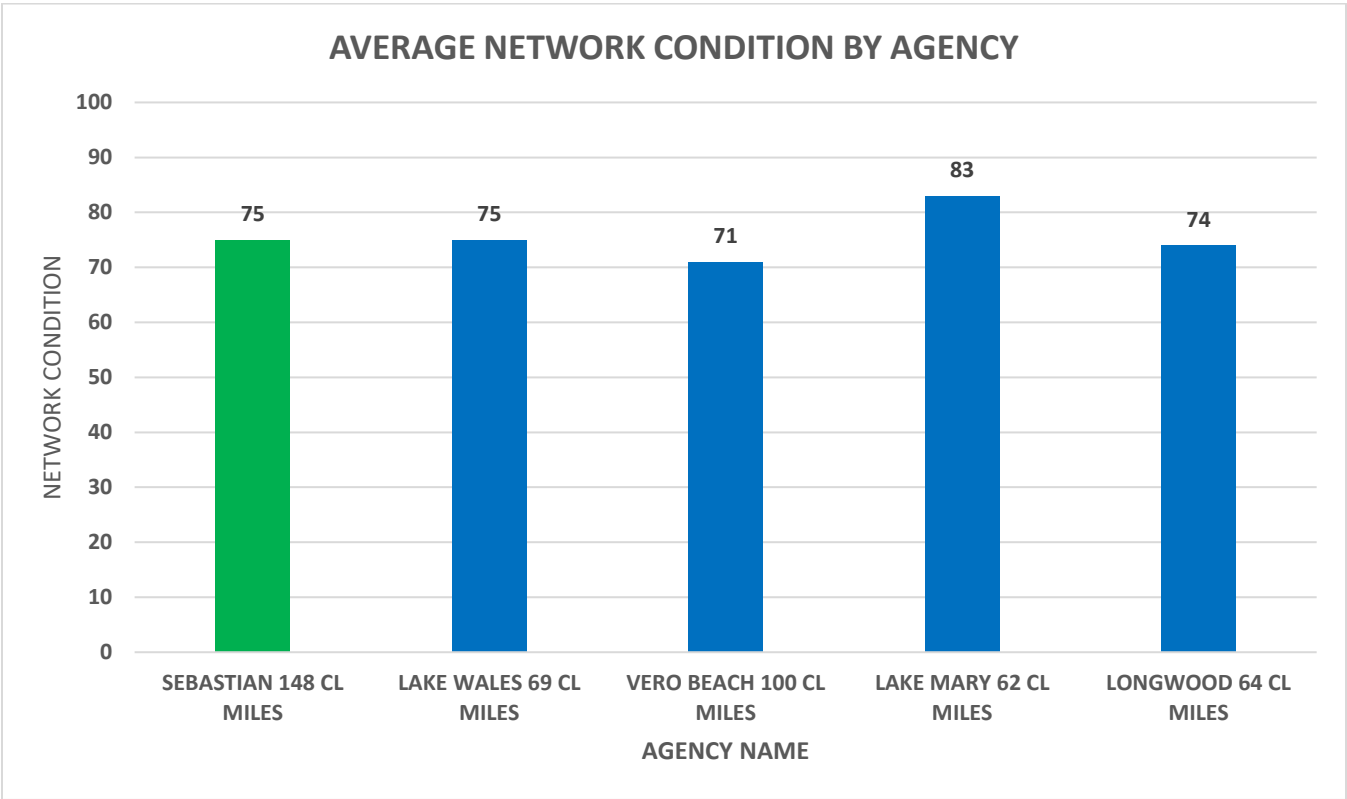
Figure 8. Local Agency Condition Comparison

PMG provides pavement management services to a wide variety of agencies within the Florida region, all on the ASTM D6433 standard and PCI 0 – 100 scale. The following chart shows a condition comparison of several agency street networks within the local region:
